Inspection Report - Distribution network - 10kV Tension Pole

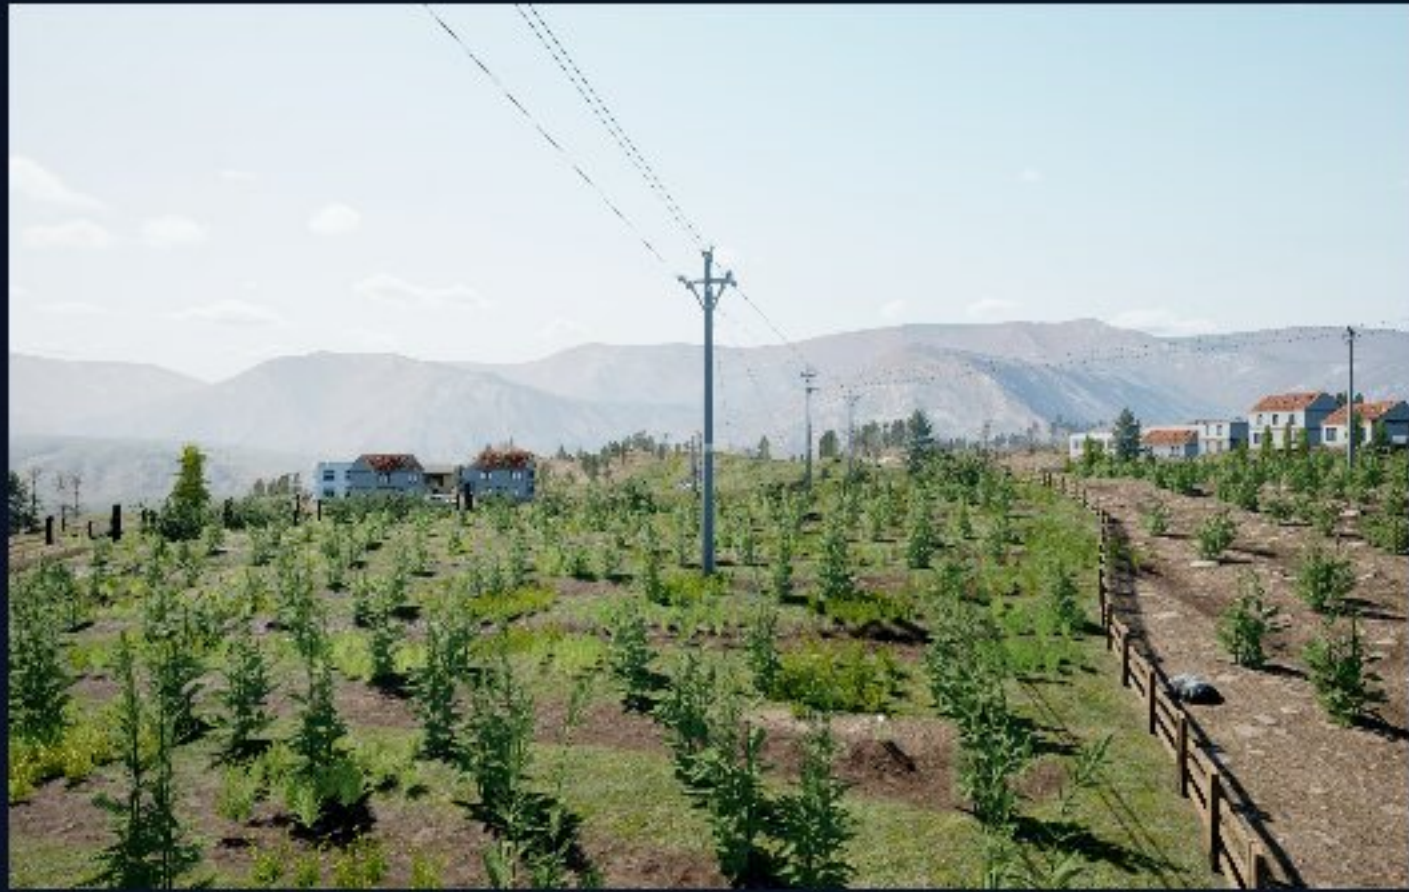
Serial number	Inspection location	Defect issue	Photo	performance evaluation
1	Full body of the pole

Correct
2	Pole number plate

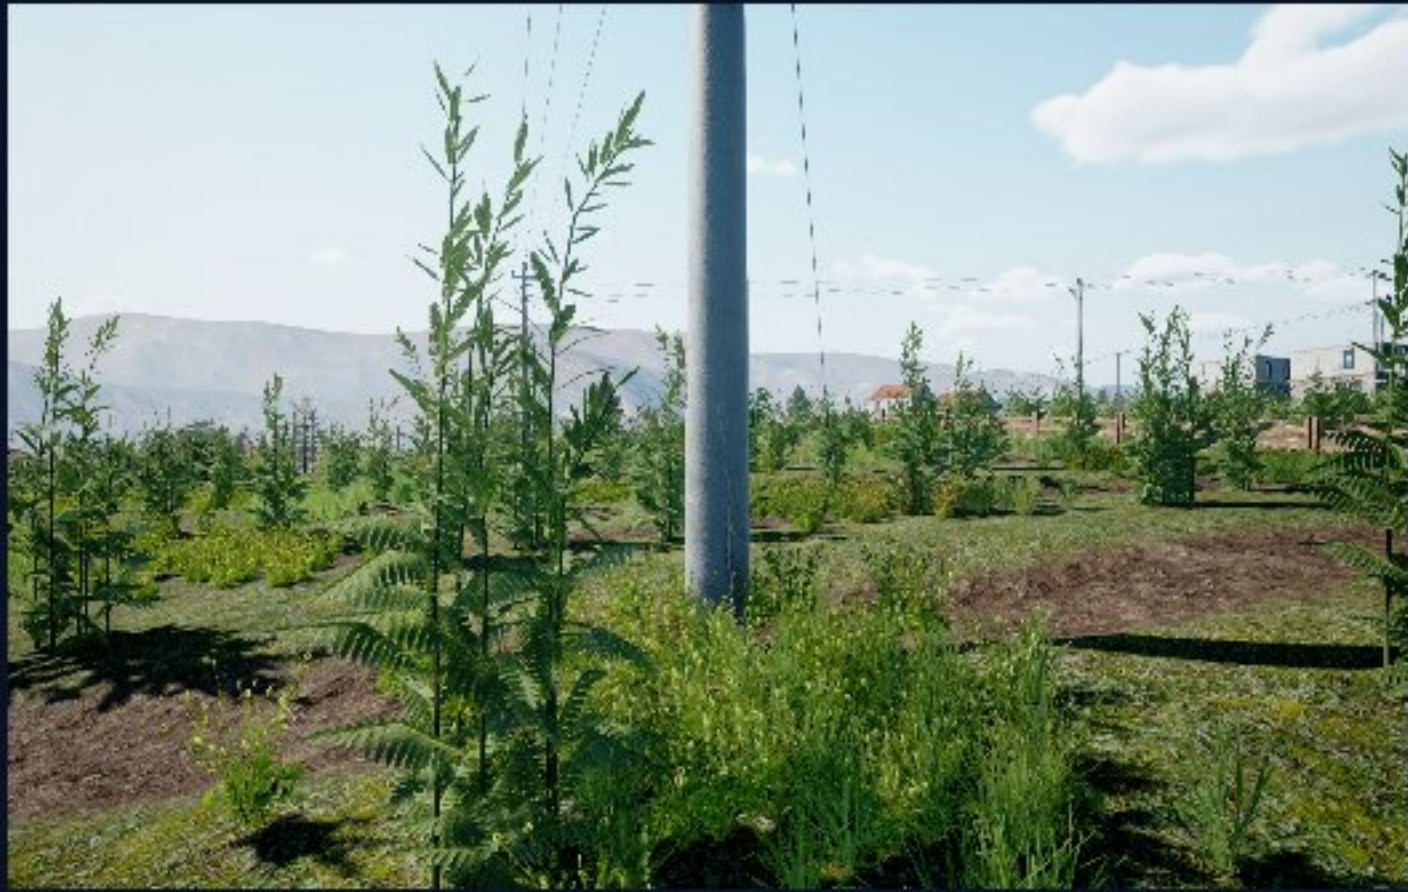
Serial number	Inspection location	Defect issue	Photo	performance evaluation
3	Base of the pole

Correct
4	Left pole top

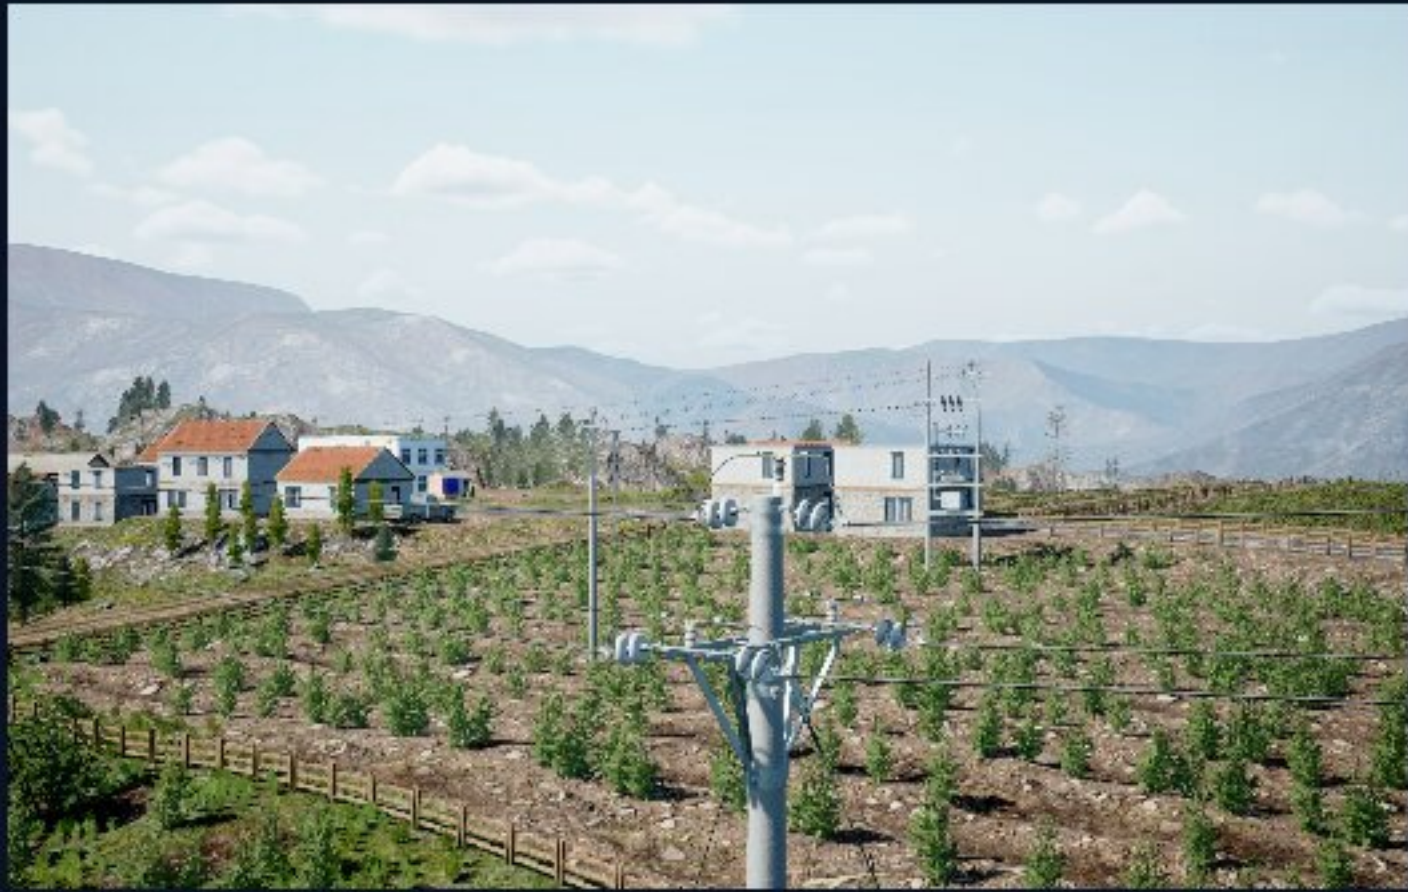
Serial number	Inspection location	Defect issue	Photo	performance evaluation
5	Pole top

Correct
6	Right pole top
